Duff House May 2021: An Exercise in 25-Year Testing of an automatic fire sprinkler system

Duff House
24 – 27 May 2021
25 Year test of Automatic
Sprinkler System

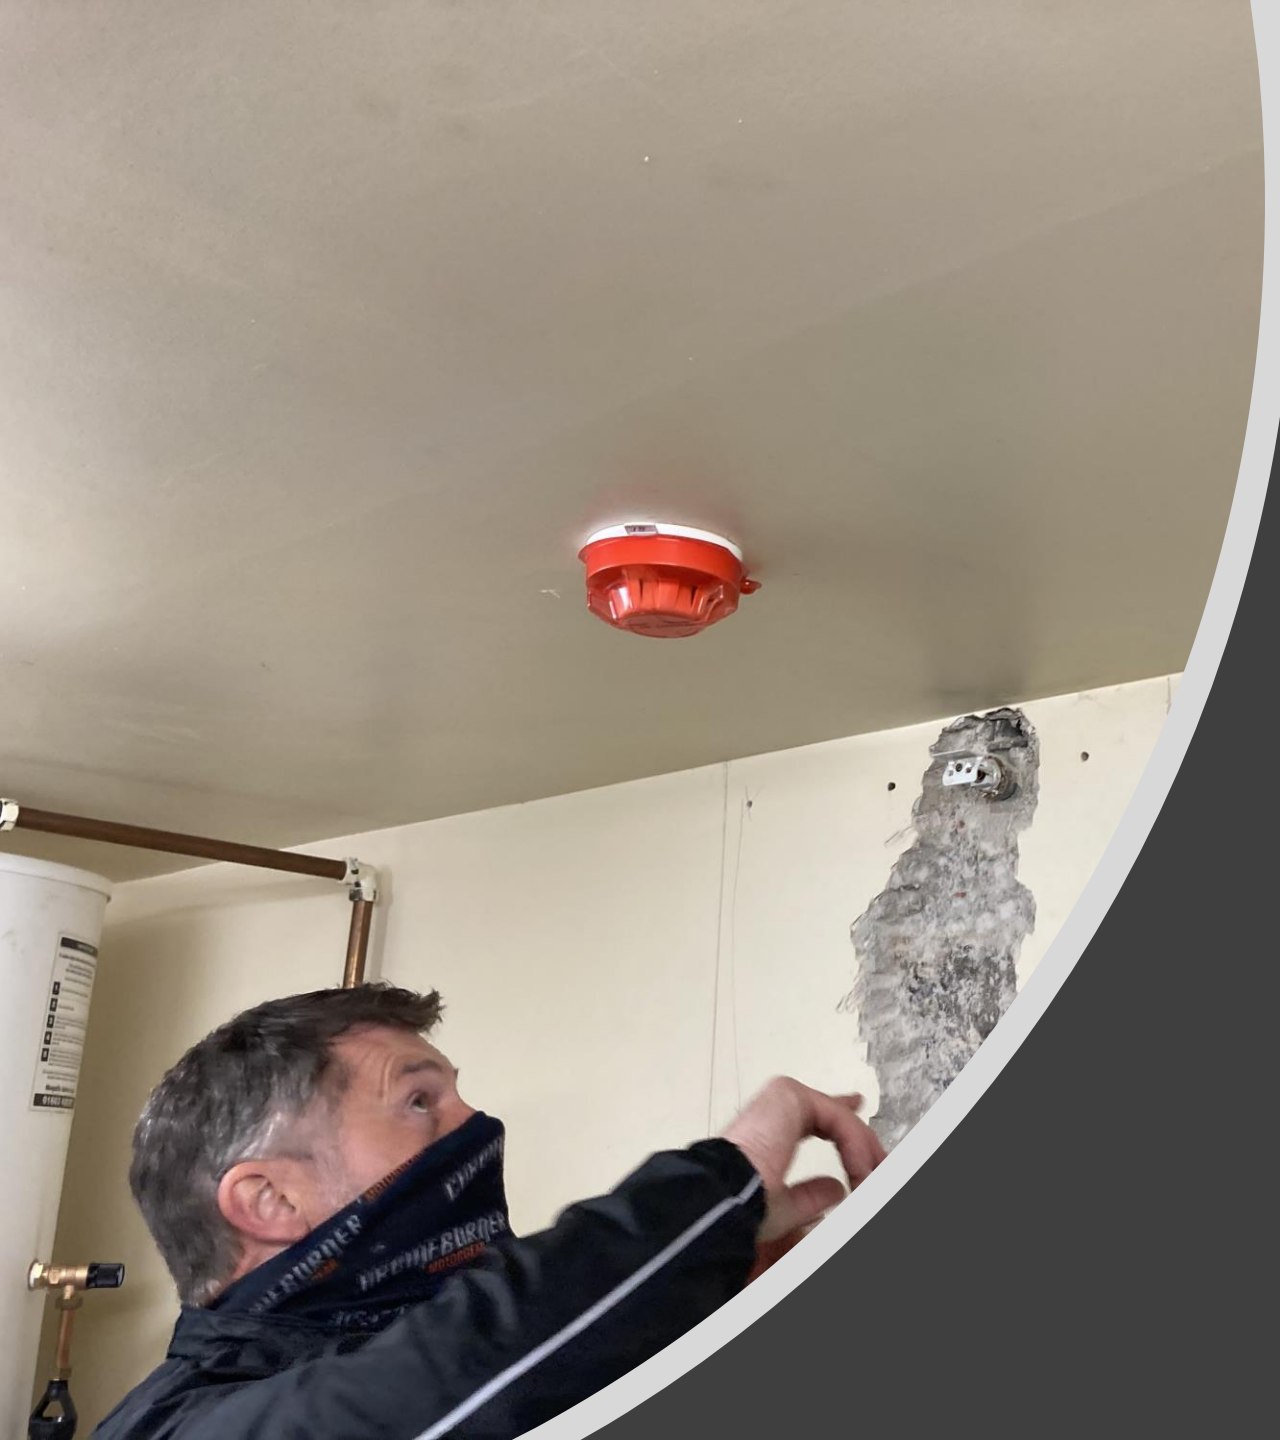
Some heads had to be excavated to remove them. All chasing work done by HES craftspeople

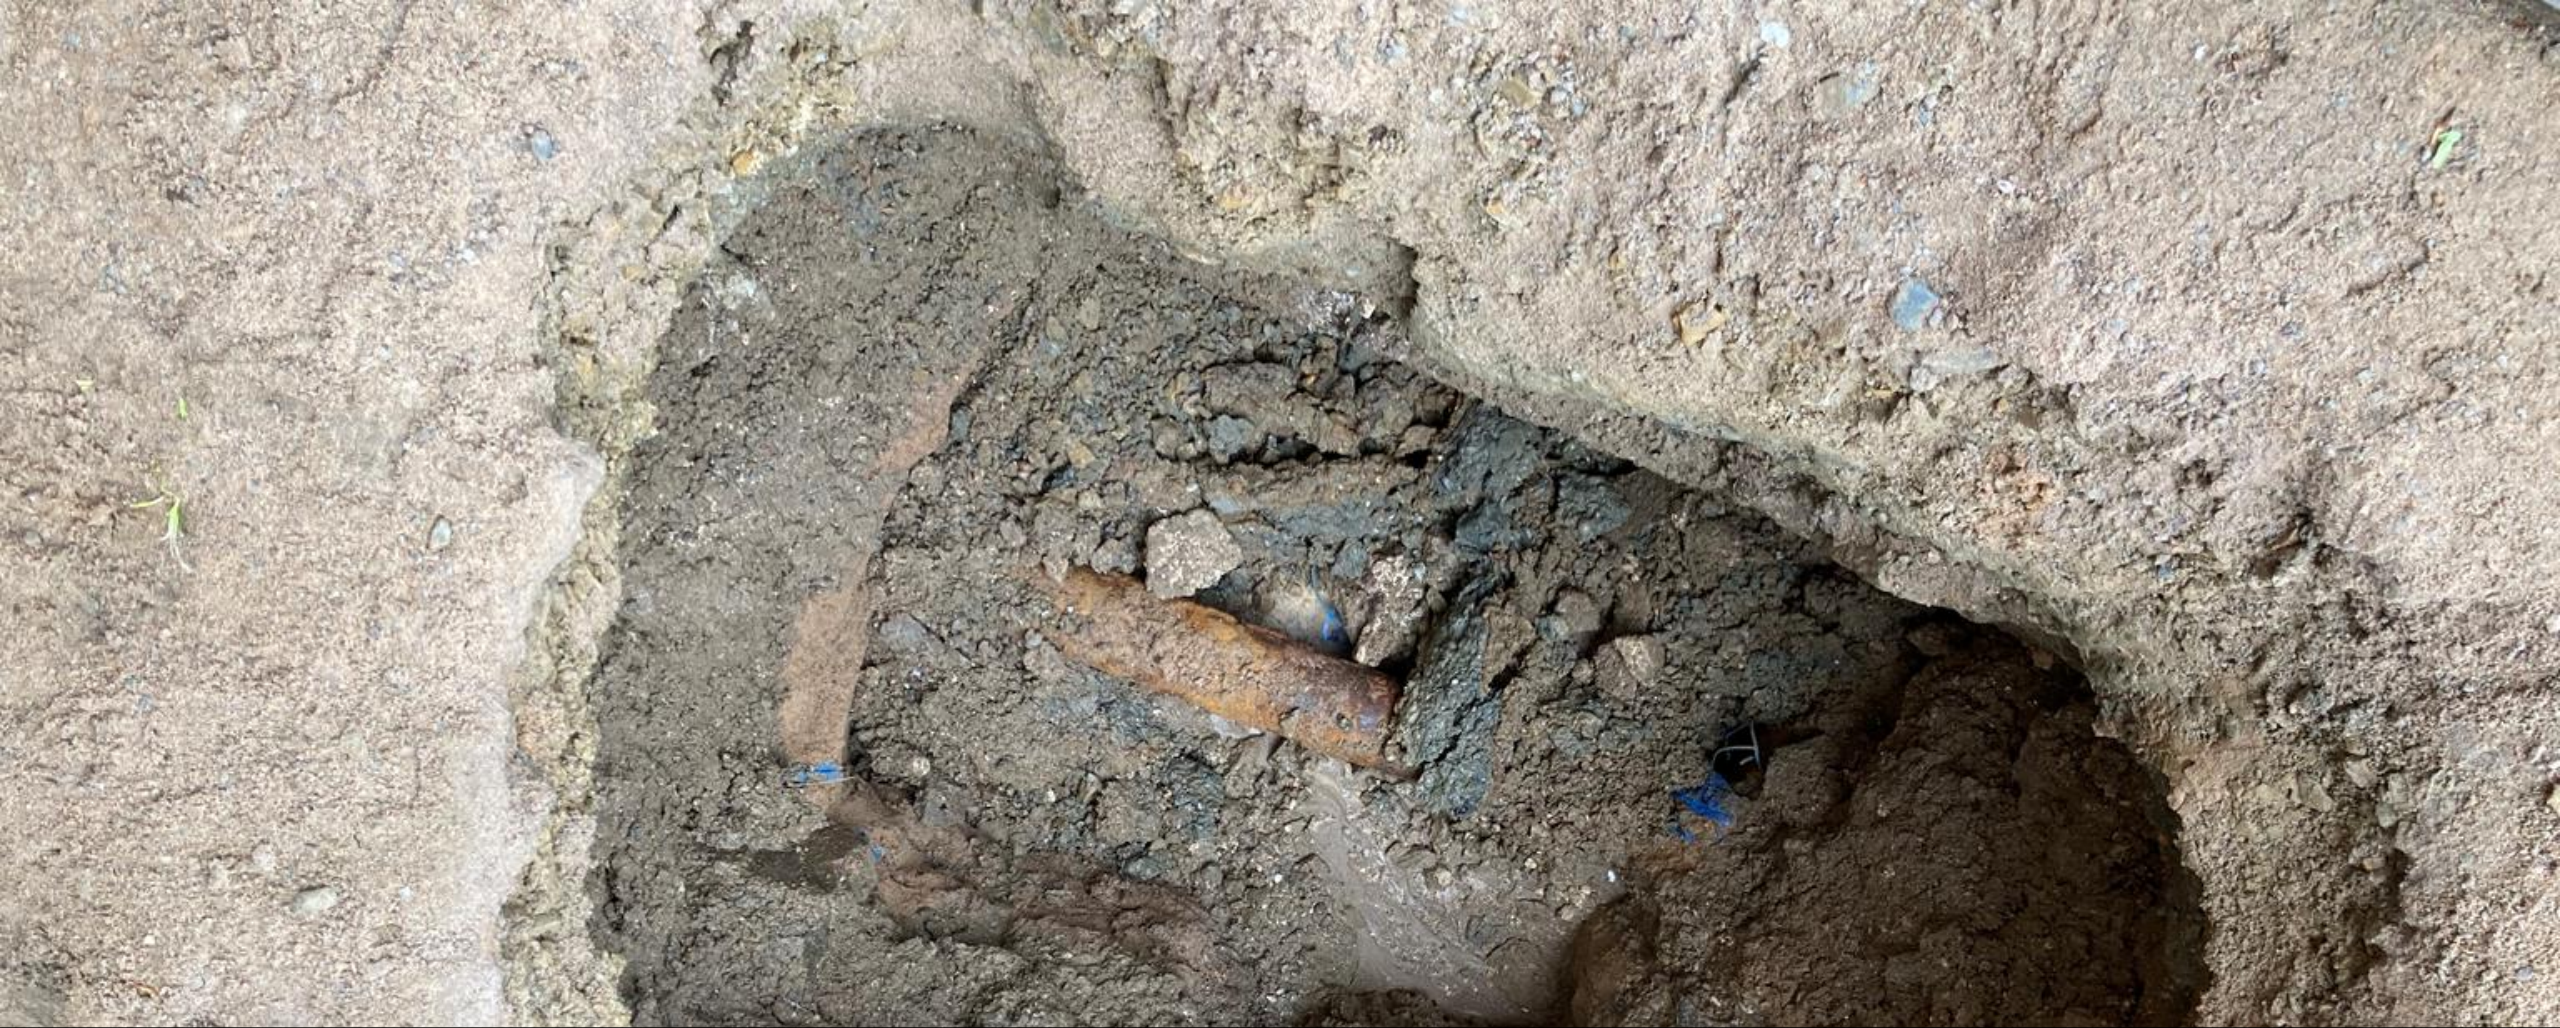
Excavation of main water supply from pump house revealed extensive external corrosion. New pump house and feed planned.

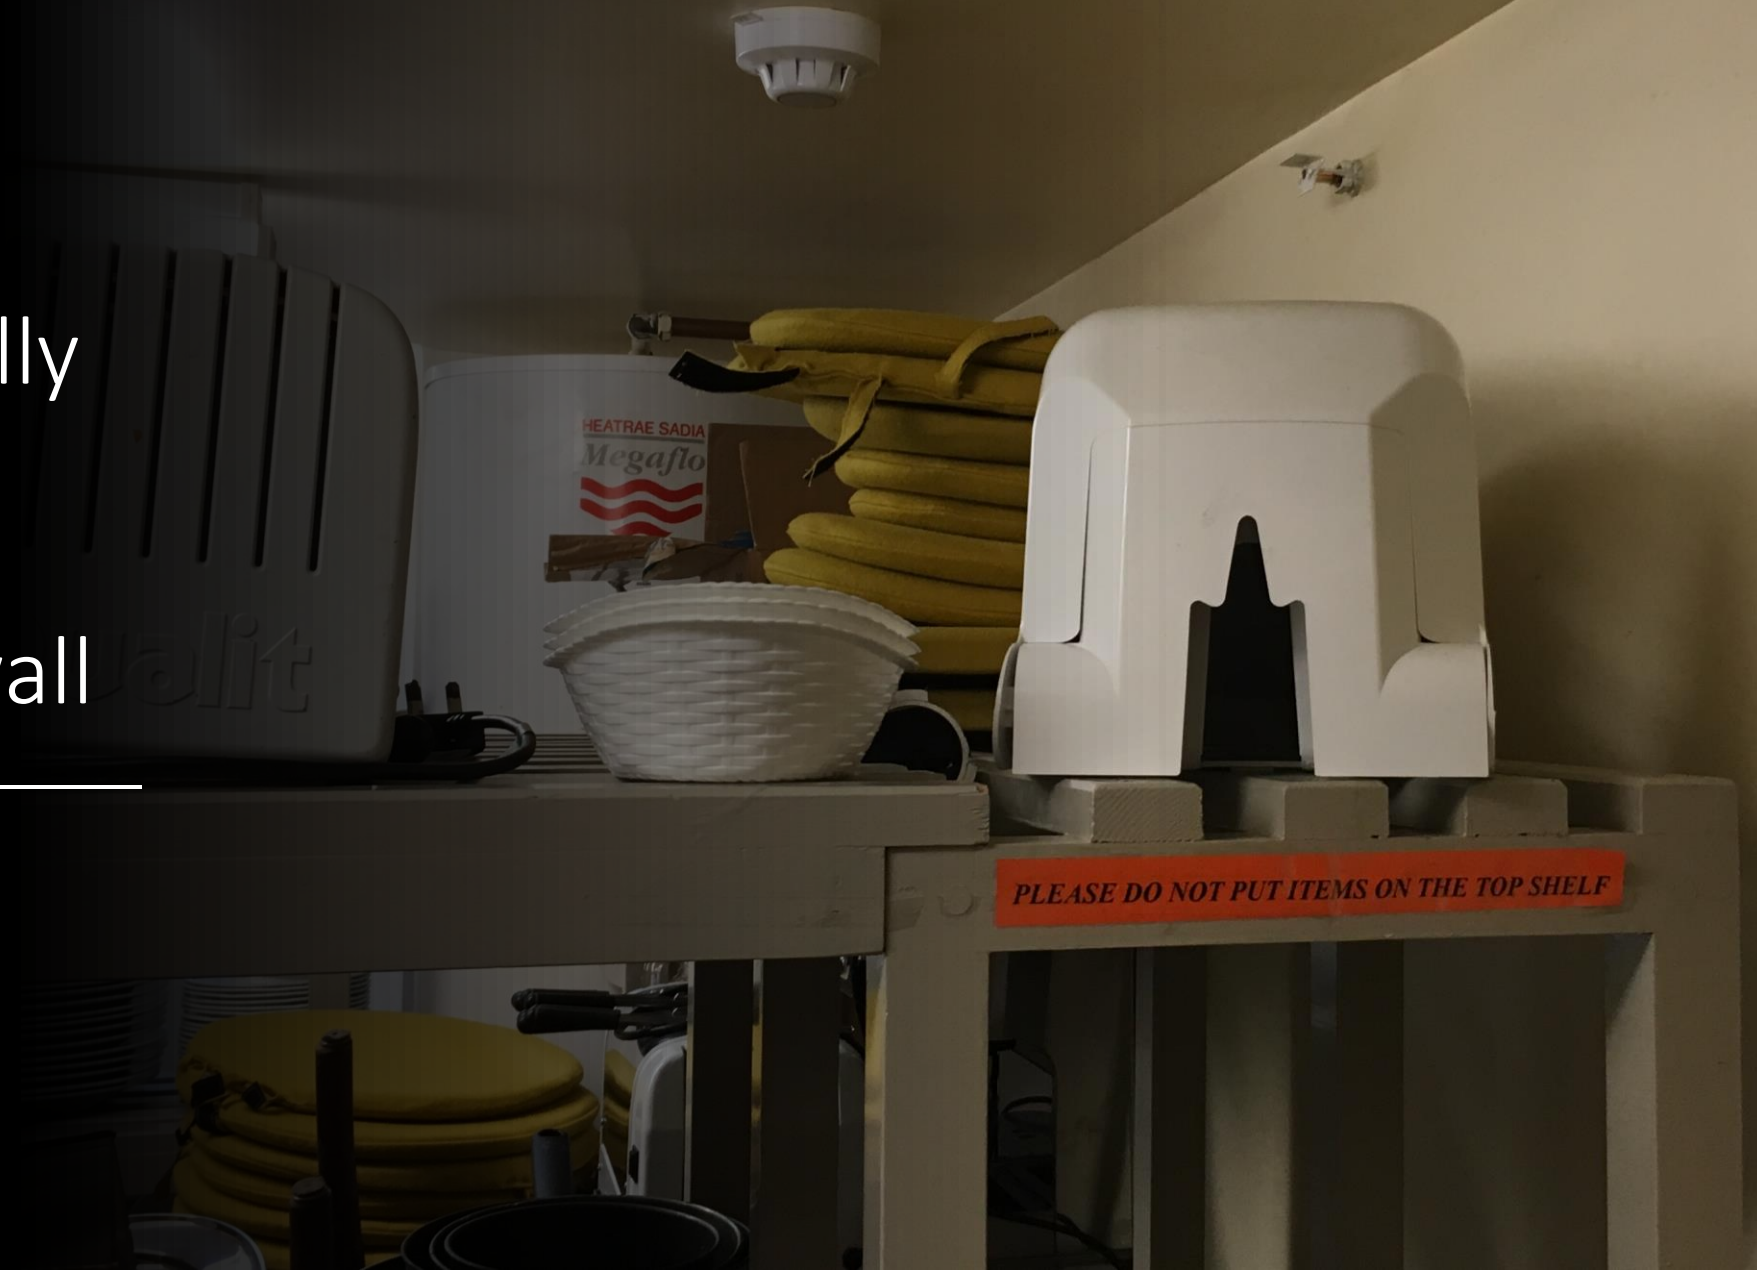
The opportunity
was taken to finally
relocate a
continuously
obstructed sidewall

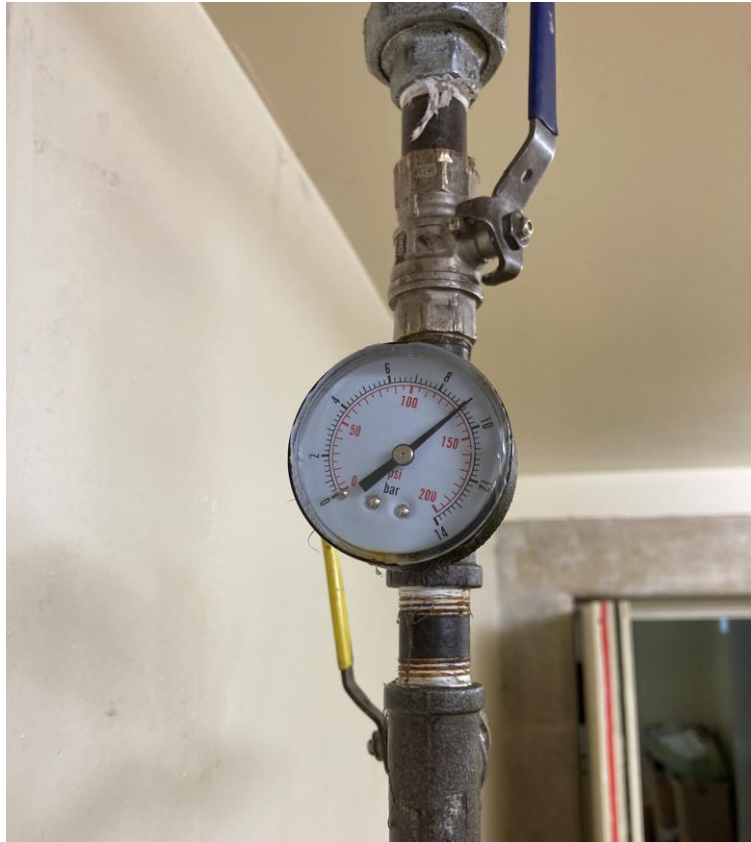
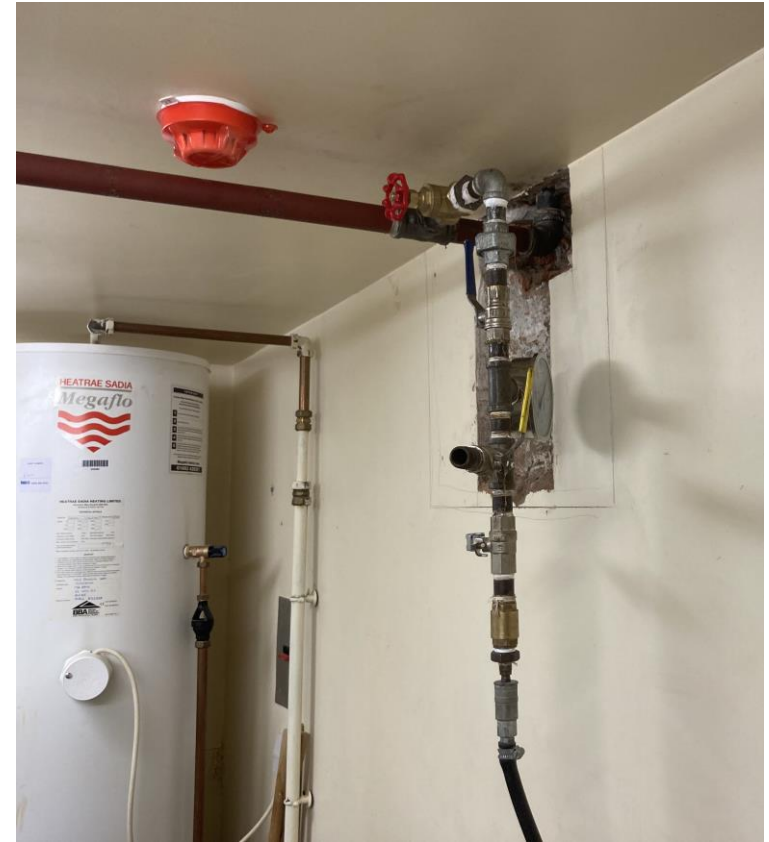
New drain valve installed at lowest point in pipework

Pressurisation unit
installed early using
new drain valve

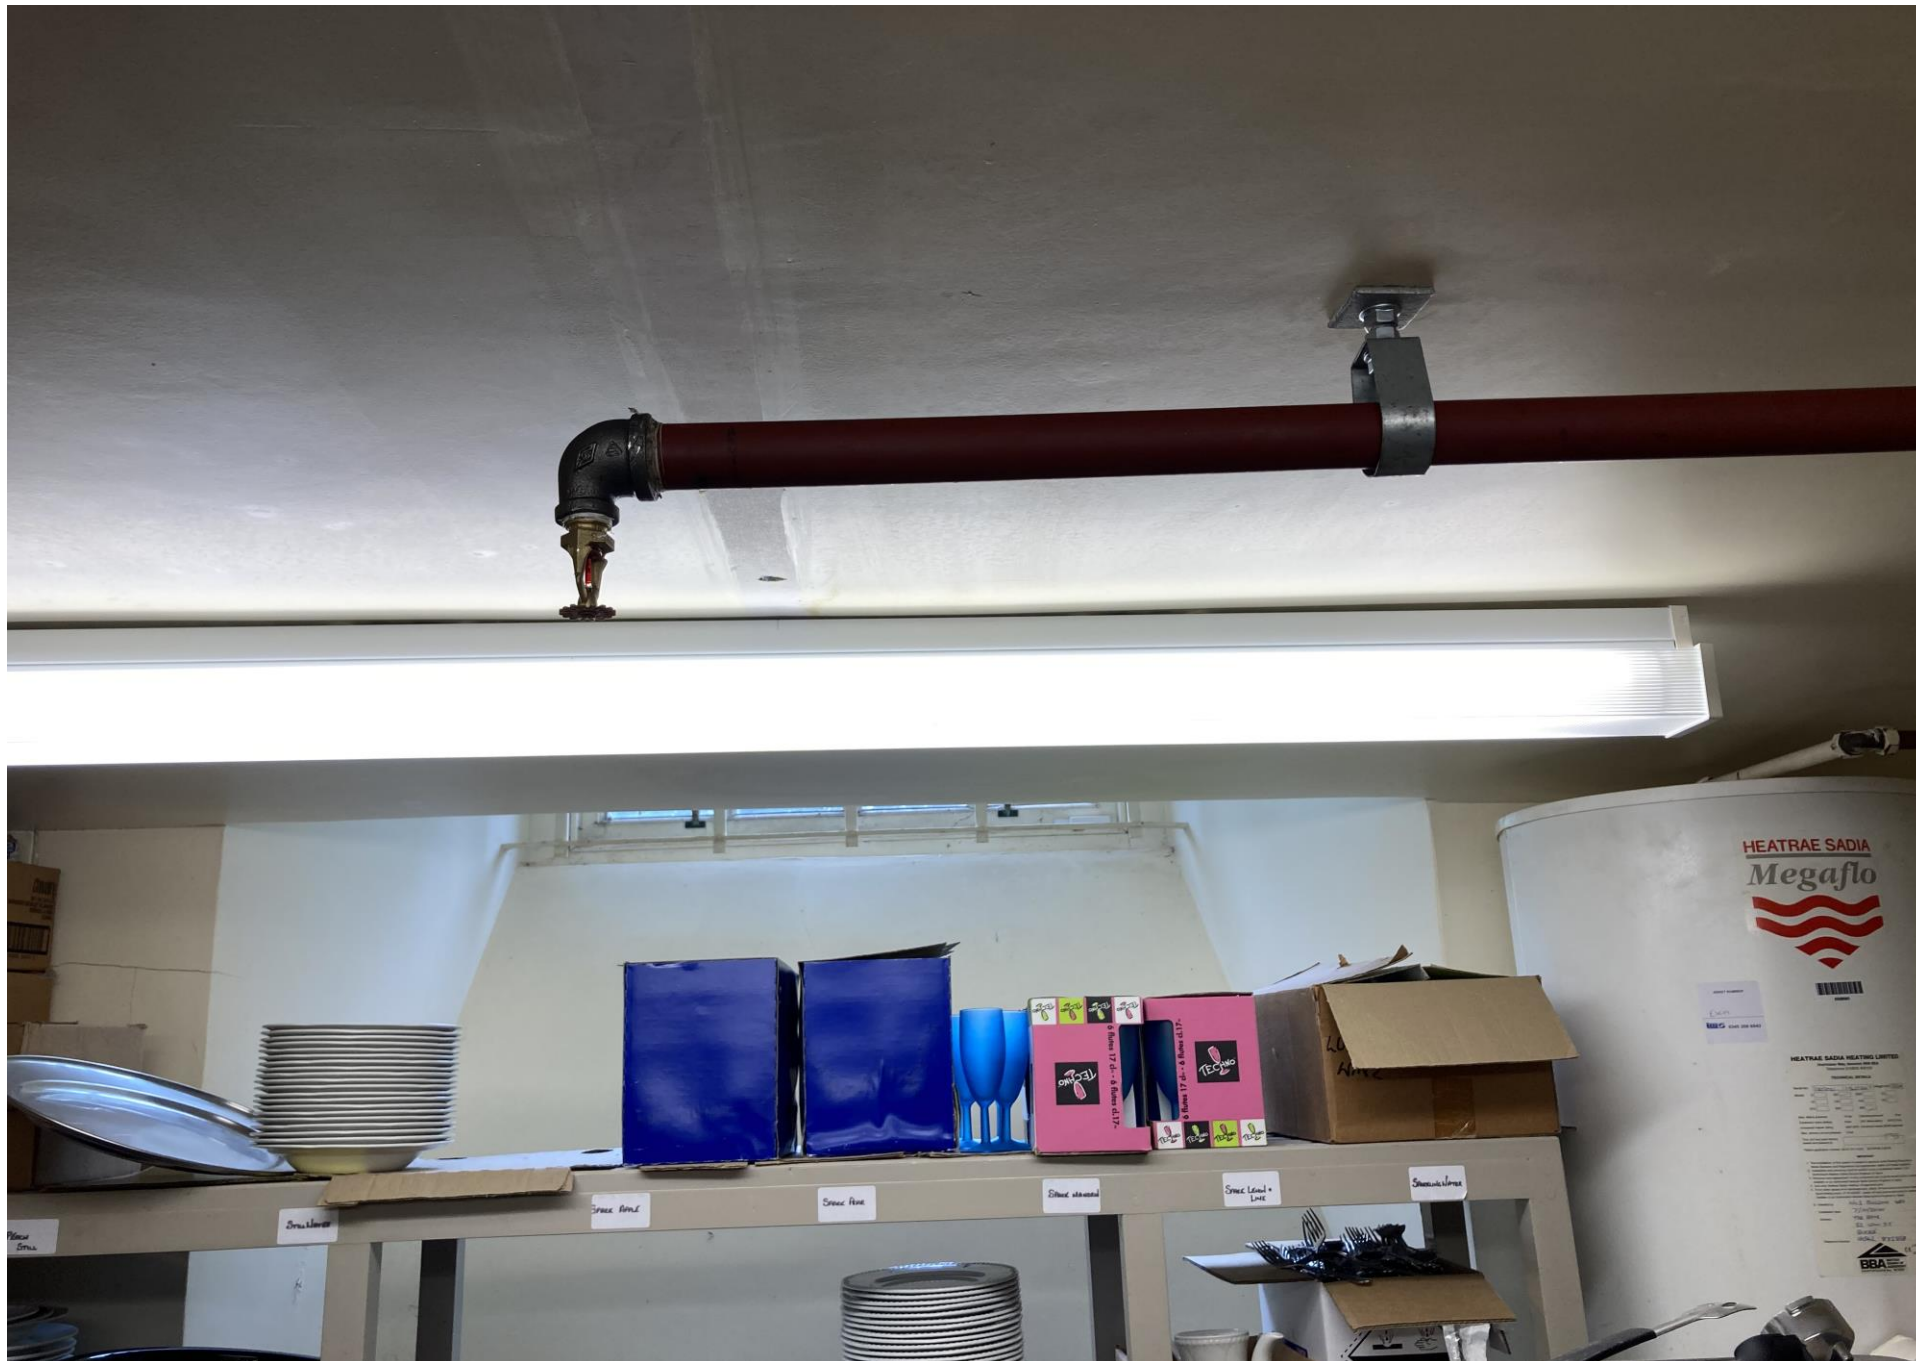
Relocated
sprinkler
head in
catering
store

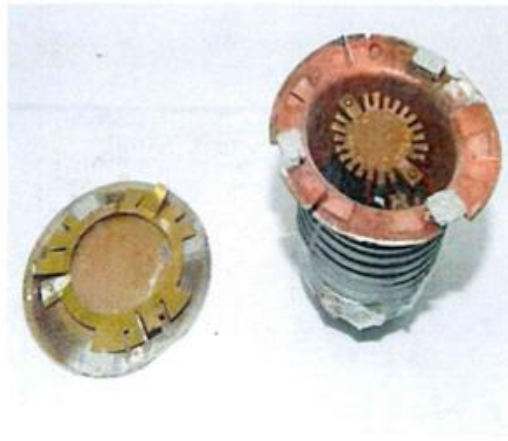
Figure 4 – Specimen 1
Ceiling plate broken off sprinkler body.

Customer Label	2nd floor, male toilet, concealed head 25/5/21
Deposits and Paint	Slight build-up of dirt/dust. Build-up of turquoise deposits on the valve assembly.
Mechanical Damage	Ceiling plate broken off sprinkler body. Distorted deflector plate tines.
Waterway	No significant foreign matter present.
Operating Mechanism	57°C, orange, glass bulb, 3mm Ø.
Markings	Deflector plate: 'SSP', 'U.S. PAT. NO. 4.880.063', 'ULC', 'Q.R. SPKR', 'UL 701A', '1994', 'F4FR', '135°F/57°C'.

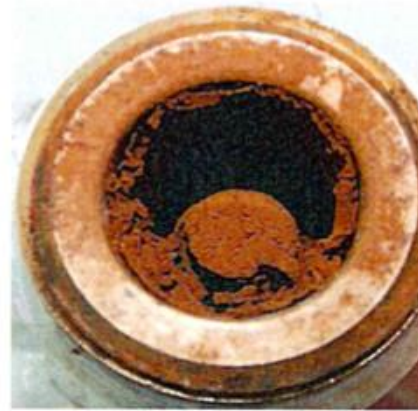
Figure 5 – Specimen 3
Build-up of brown deposits in the waterway

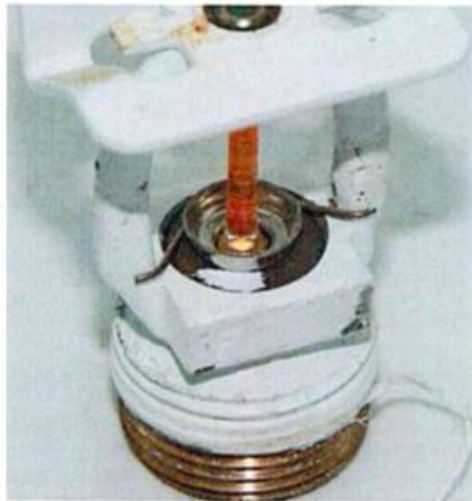
Figure 6 – Specimen 7
Paint daubed on the valve assembly
and non-critical areas.

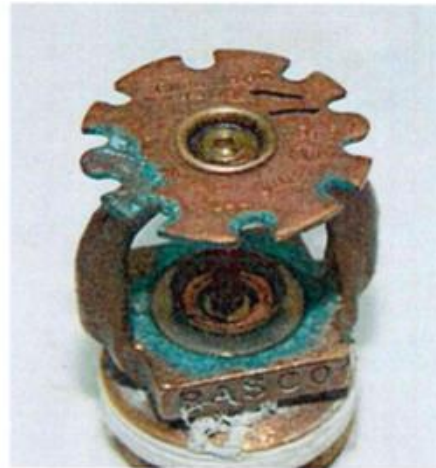
Figure 7 – Specimen 11
Build up of turquoise deposits on
The deflector plate, valve assembly
and non-critical areas

Customer Label	Attic space, 25/5/21
Deposits and Paint	Slight build-up of dirt/dust. Build-up of turquoise deposits on the deflector plate, valve assembly and non-critical areas (see Figure 7).
Mechanical Damage	None identified.
Waterway	Build-up of brown deposits.
Operating Mechanism	68°C, red, glass bulb, 3mm Ø.
Markings	Deflector plate: '1994', 'UL 701A', 'ULC', '68°C', '155°F', 'F1FR', 'Q.R. EC', 'PEND.'. Flats: 'RASCO', 'F1'.

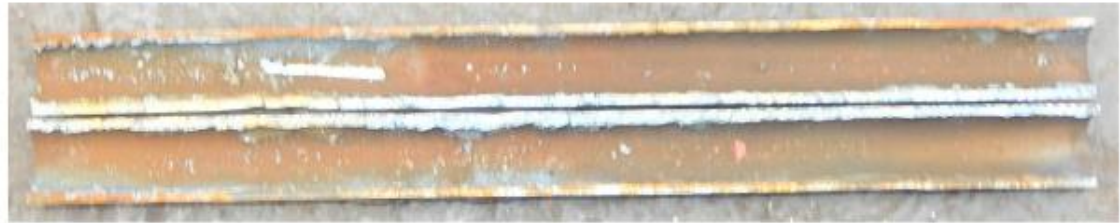
Figure 3 – Internal view of specimen 1

Markings	'ATTIC', '25/5/21'.
Description	1" Medium Gauge steel pipe, painted red and threaded at both ends with an elbow attached to one end.
External Condition	Generally clean and appeared to be in good physical condition.
Internal Condition	Layer of orange corrosion/sediment.
Length	68cm.

Specimen Number	Measured Mean Thickness of Deposits on the Internal Surface (mm)	Approx. Reduction in Cross Sectional Area of Pipe Due to Deposits (%)
1	0.2	2.9
2	0.2	1.4

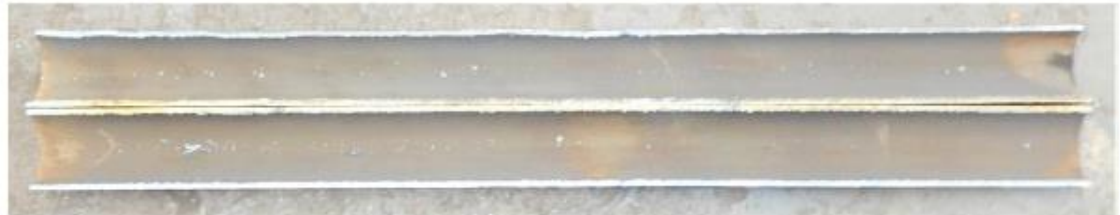
Figure 4 – Internal view of specimen 2

Markings	'1st Floor Cloackroom', '25/5/21'.
Description	2" Medium Gauge steel pipe, painted red.
External Condition	Generally clean and appeared to be in good physical condition.
Internal Condition	Thin layer of black corrosion/sediment.
Length	100cm.
