Building trust in sprinkler systems

Joint presentation by

Fire Sprinkler International 2023, Amsterdam

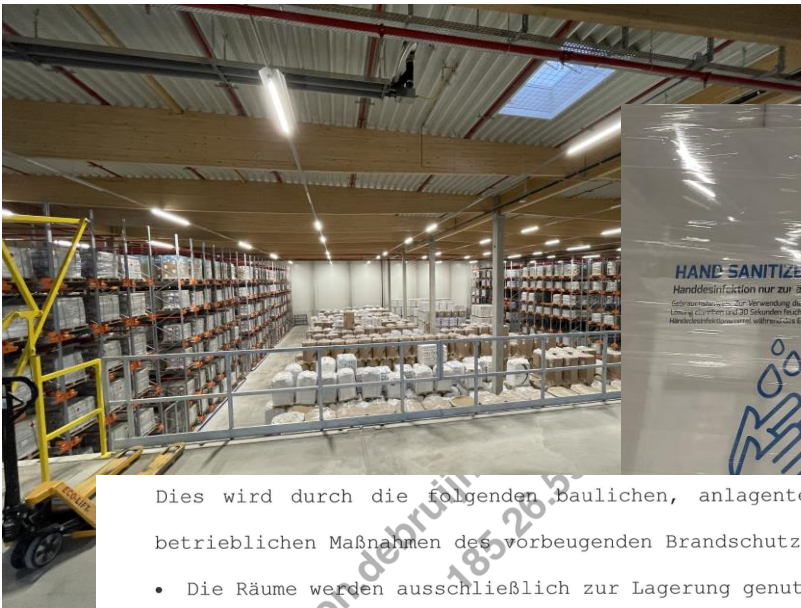
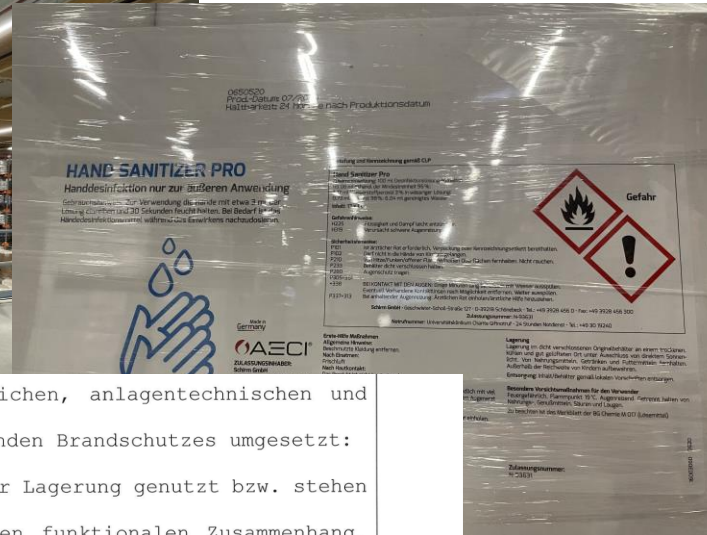
Löschanlagenkonzept HE3 Enterprise - Logistikzentrum, Schwalmtal

Die Lagerung in mehrreihigen Regalen erfordert die selben Auslegungsparameter wie oben beschrieben. Jedoch ist der Gangsprinkler in jedem Querschacht anzuordnen (siehe auch Bild unten oder FM Global DS 7-29 Scheme A für mehrreihige Regale).

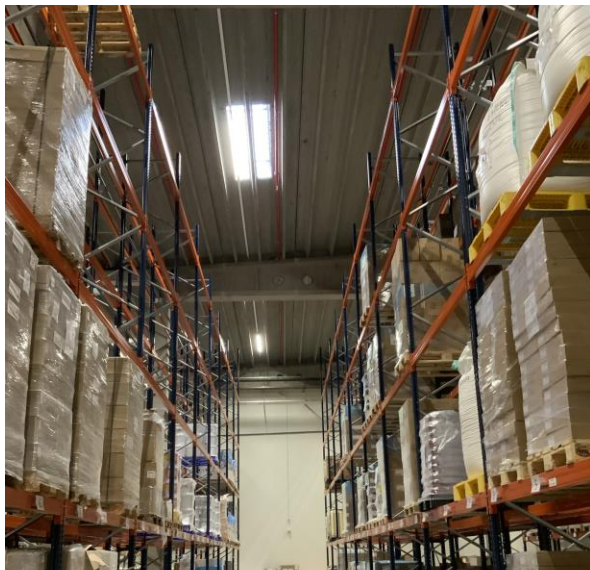
2205-5 Sprinkler system-2

Risk rating	Reduction of loss estimates	Impact	Extreme
Impact rating	--	Cost indication	250.000 – 400.000
Observation	The building's ceiling sprinkler system is designed as an ESFR sprinkler system, using FM datasheets. The design is based on K 200 sprinklers with a minimum pressure of 3,5 bar on the sprinklers. The internal building height varies between 11,5 and 12,0 meters. With the chosen design, no storage is actually possible in accordance with FM Datasheet 8-9. For ESFR protection for internal building heights up to 12,0 meters, the following design criteria must be implemented for storage in pallet racks and in bulk (palletized and solid Piled):		
	<ul style="list-style-type: none"> > Class I to Class III commodities: K 200 @ 5,2 bar > Class IV and Cartoned Unexpanded Plastics: K 200 @ 5,2 bar > Cartoned Expanded Plastics: K 320 @ 5,2 bar > Uncartoned Unexpanded Plastics: K 320 @ 5,2 bar

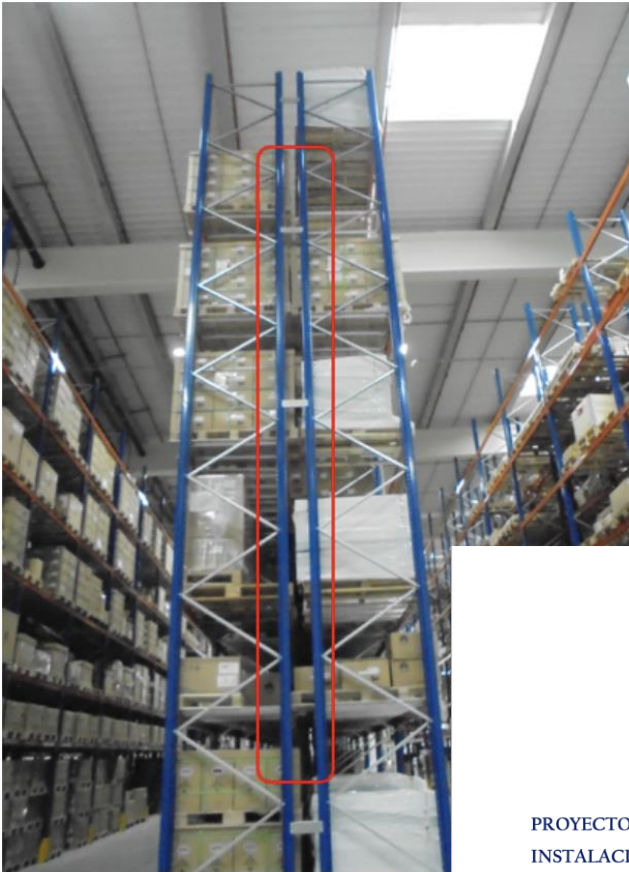
Absence of longitudinal aisle

- The system is designed before the occupancy and tenants are known
- The building is delivered empty and is approved by the authorities and an occupancy permit is issued
- A tenant was found who required a certain amount of pallet locations.
- By moving the double row racks as close as possible to each other an additional double row rack can be installed
- No flue spaces left in a building protected with an ESRF system
